Debris/Ice/TPS Assessment And Photographic Analysis For Shuttle Mission STS-38

February 1991

DEBRIS/ICE/TPS ASSESSMENT
AND
PHOTOGRAPHIC ANALYSIS
OF
SHUTTLE MISSION STS-38

November 15, 1990

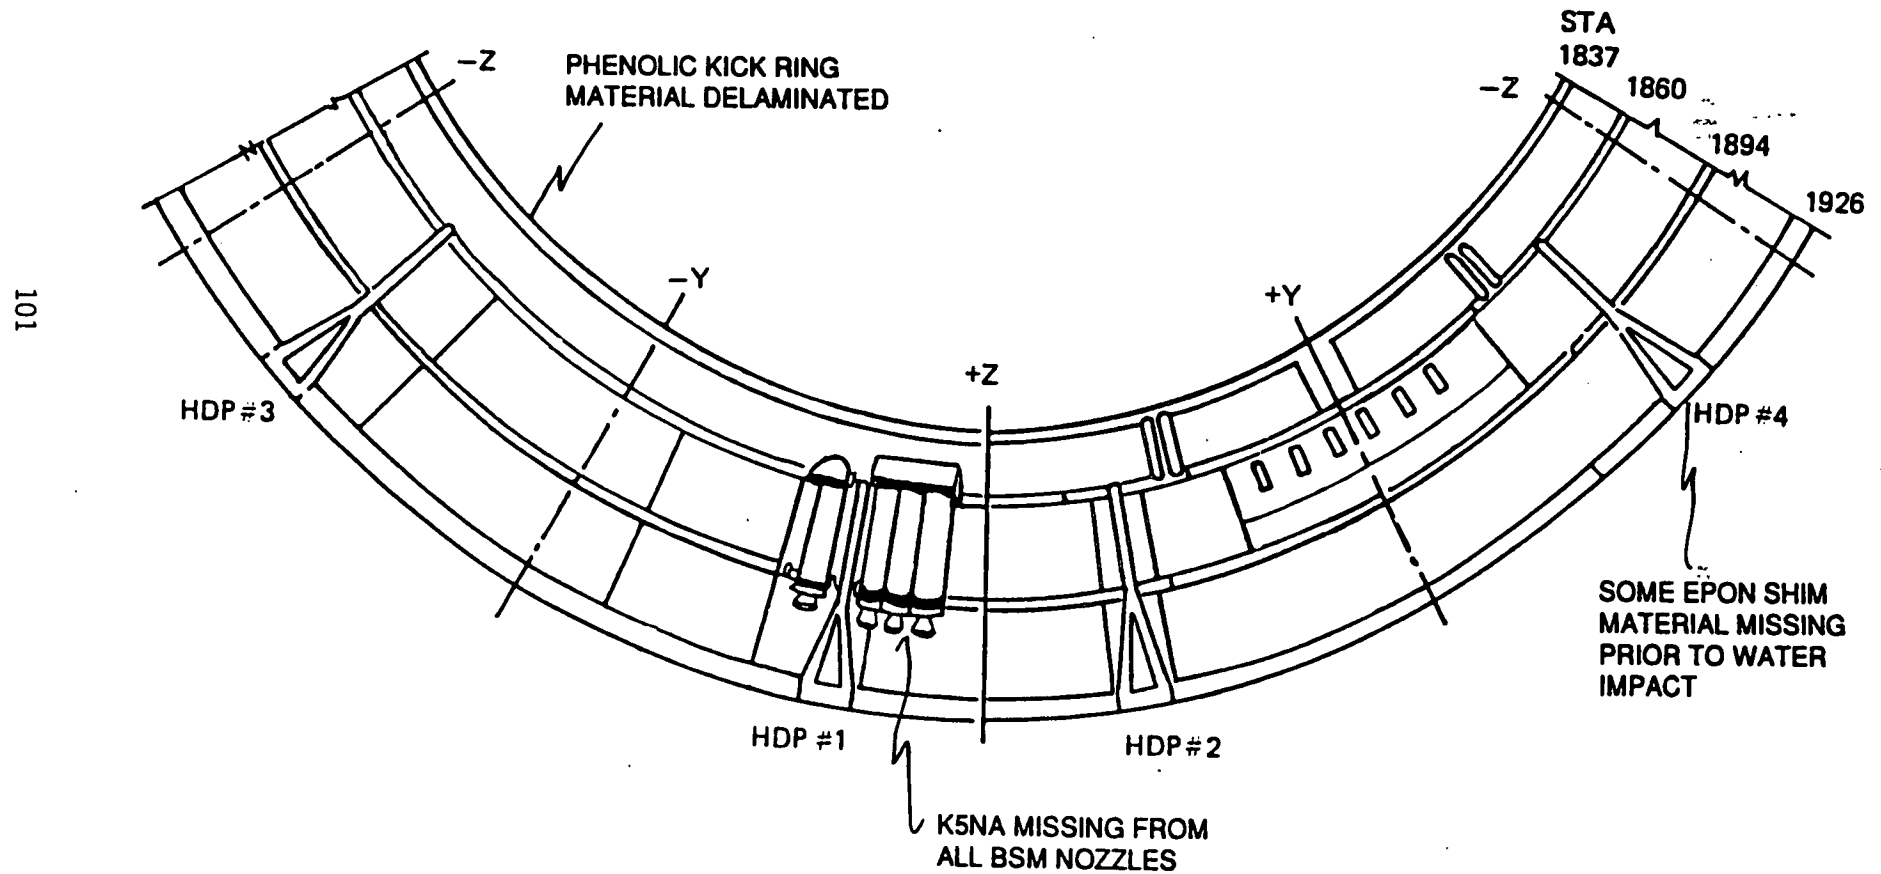
FIGURE 7. RIGHT SRB AFT SKIRT EXTERIOR TPS

The TPS over the aft skirt acreage was generally in good condition with localized blistering of the Hypalon paint (Figure 7). The TVC system appeared to be undamaged. The phenolic material on the kick ring delaminated in several locations. K5NA protective domes were missing prior to water impact at 5 locations. K5NA was missing from all aft BSM nozzles. Instafoam was missing from the aft ring around the aft skirt feet, HPU exhaust horns, and the SRB T-0 umbilical. All four Debris Containment System (DCS) plungers were properly seated. Some Epon shim material was missing from the aft skirt HDP #4 foot and the substrate was sooted. This condition coincides with the piece of EPON shim material that came loose after liftoff (ref Film Item E-7).

ALL DCS PLUNGERS
WERE PROPERLY SEATED

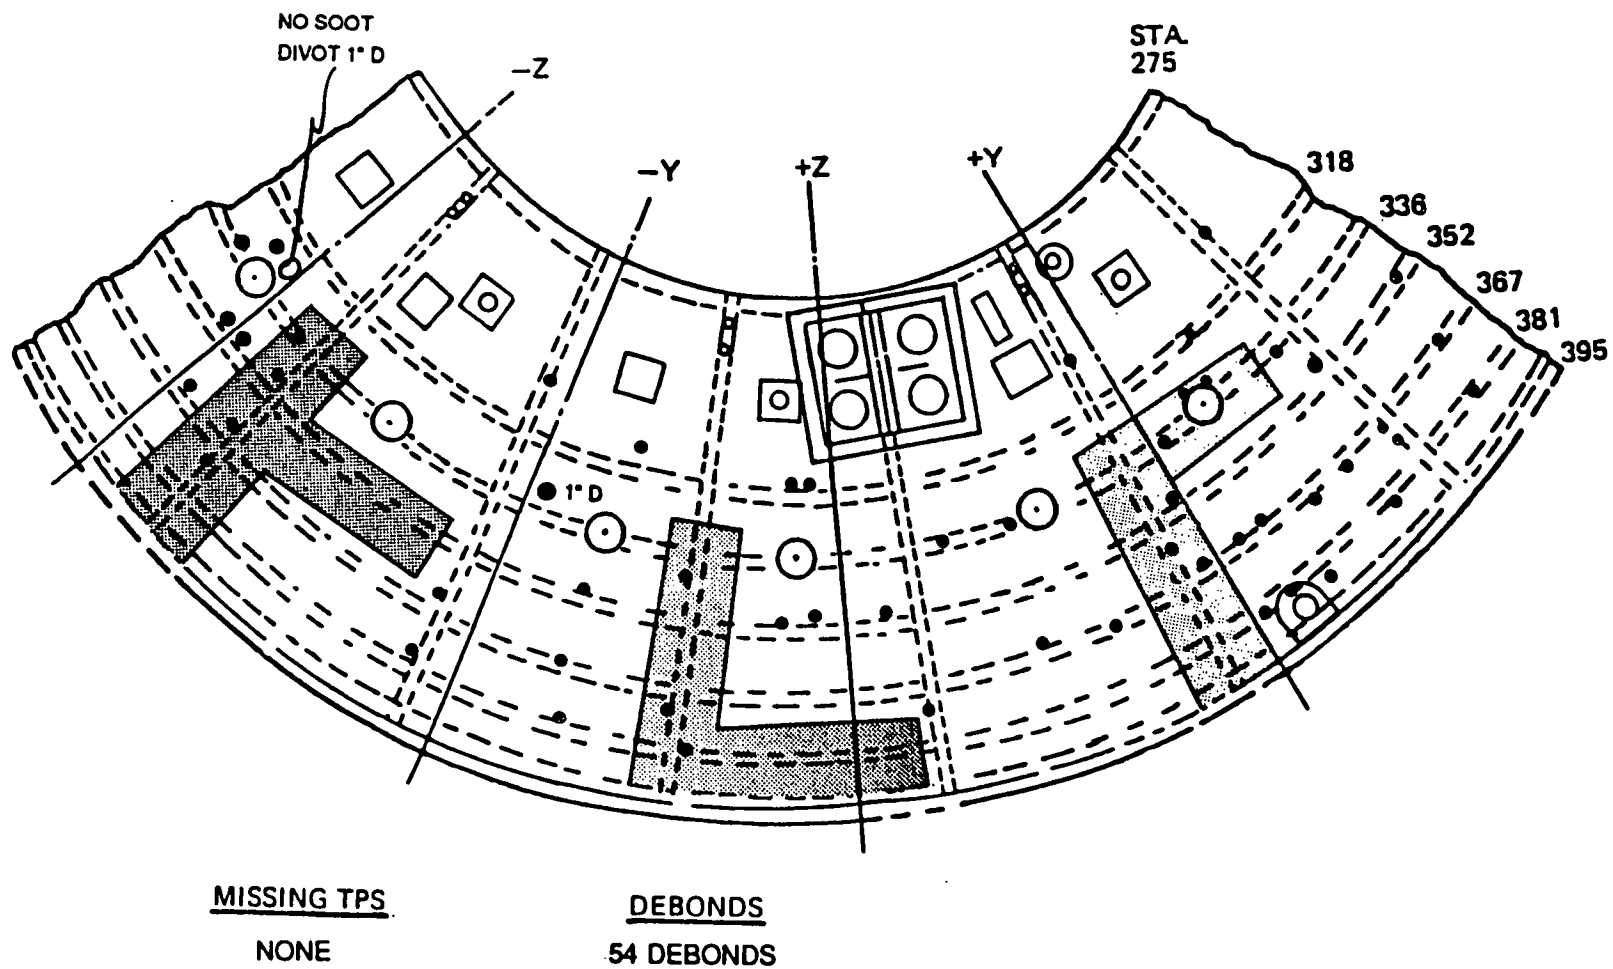
FIGURE 8. LEFT SRB FRUSTUM

The nosecap was not recovered. The LH frustum exhibited no missing TPS but had 54 debonds over fasteners (Figure 8). All of the BSM covers were fully opened and locked in the 180 degree position.

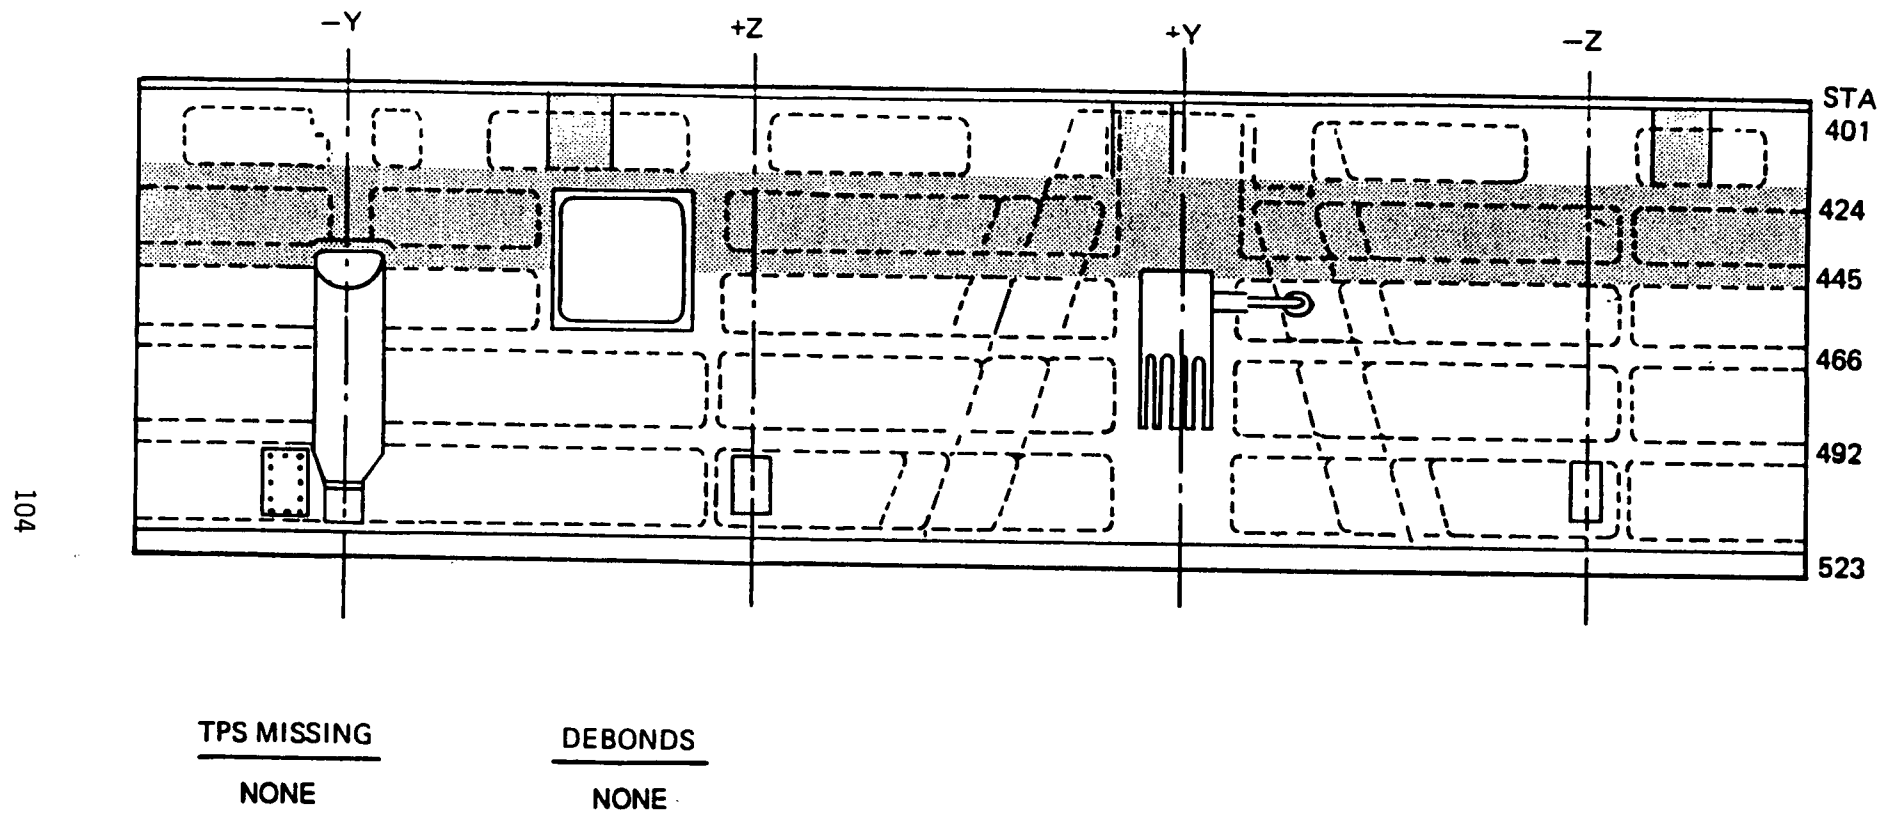
FIGURE 9. LEFT SRB FWD SKIRT

The LH forward skirt exhibited no debonds or missing TPS (Figure 9). Blistering of the Hypalon paint had occurred around the forward attach point. The frustum severance ring, utilizing the new pin retainer clips, was missing no pins. Separation of the forward attach bolt and electrical cables appeared normal.

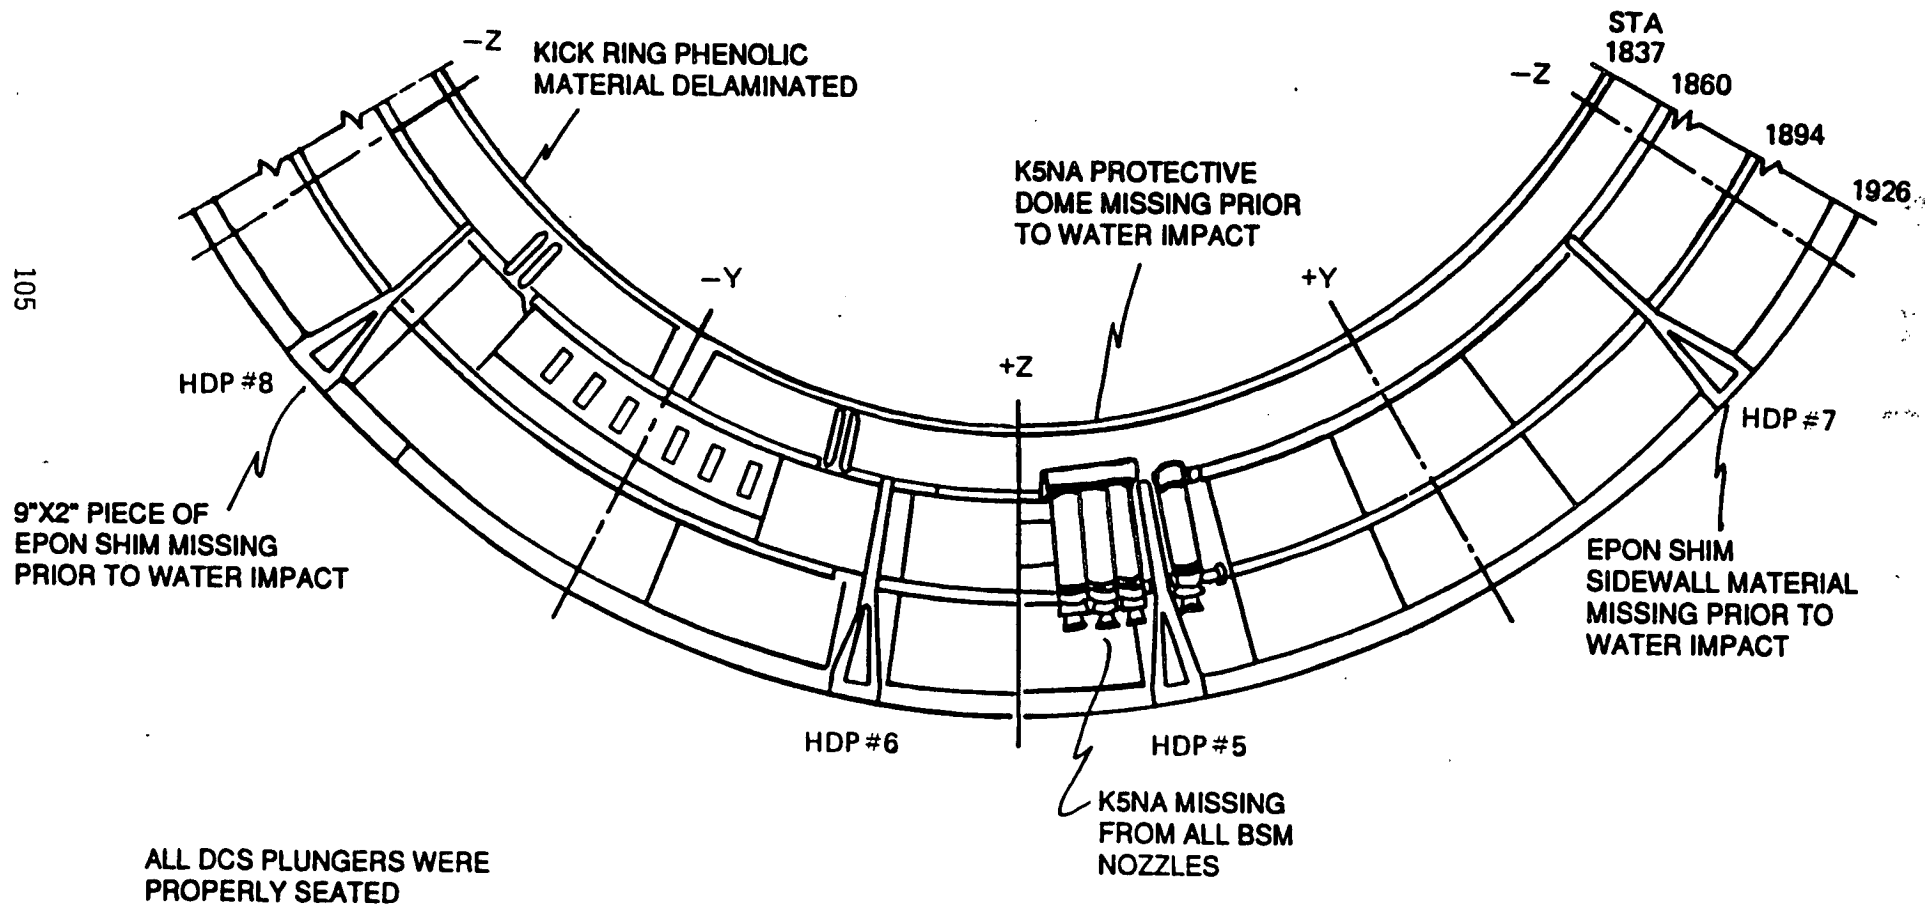
FIGURE 10. LEFT SRB AFT SKIRT EXTERIOR TPS

The TPS over the aft skirt acreage was generally in good condition (Figure 10). The phenolic material on the kick ring delaminated in several locations. K5NA was missing from all aft BSM nozzles. The TVC system appeared undamaged.

All DCS plungers were properly seated. Aft skirt HDP #7 was missing Epon shim from the inboard side of the foot and the substrate was sooted. A 9"x2" piece of HDP #8 aft face shim material was missing prior to water impact. The thermal curtain attach structure and aft skirt aft ring were inspected for damage caused by the suspected loss of a thermal curtain 34 seconds into flight, but no unusual damage was visible. Water impact may have altered any remaining evidence. Instafoam was missing from the aft ring around the aft skirt feet, HPU exhaust horns, and the SRB T-0 umbilical.

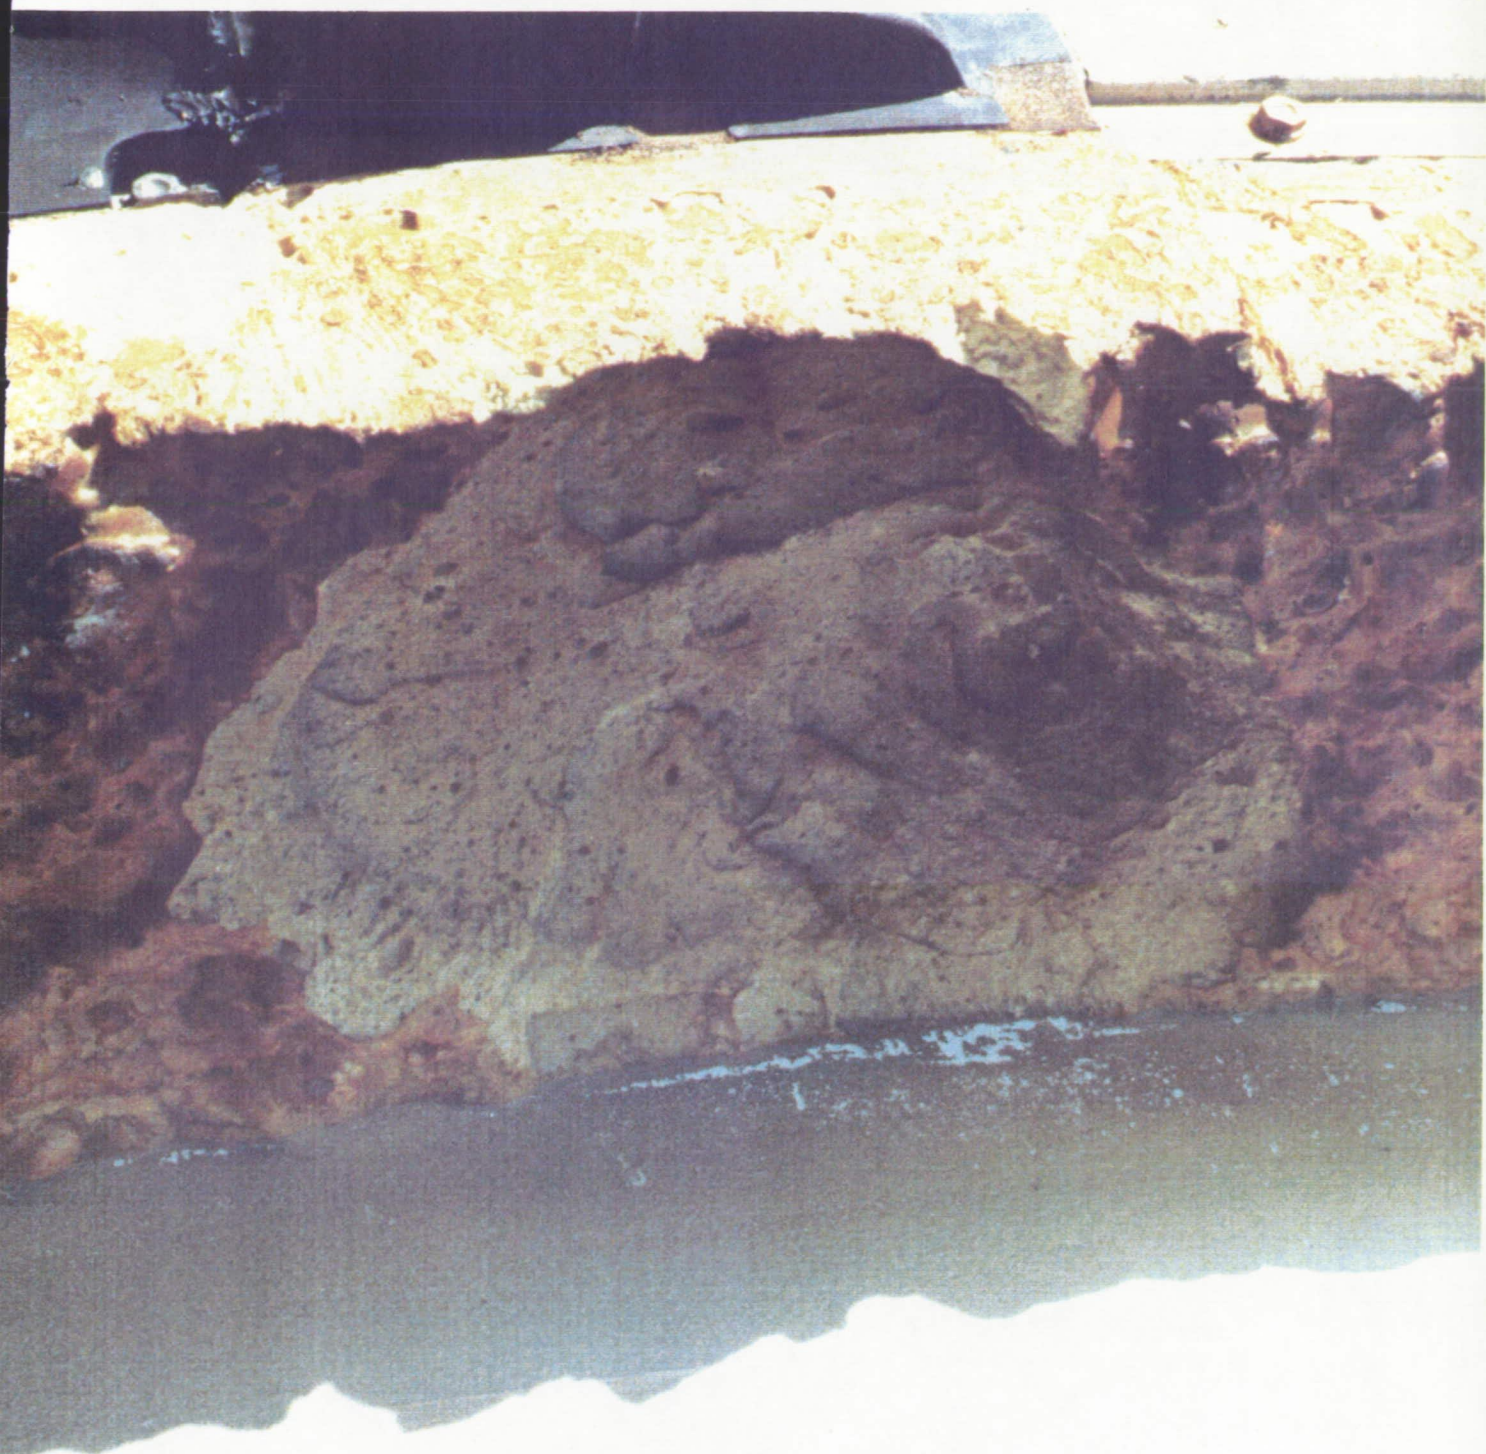
An IFA was taken against a second 8-inch instafoam divot with another 8 inches of delamination on the ETA ring forward side

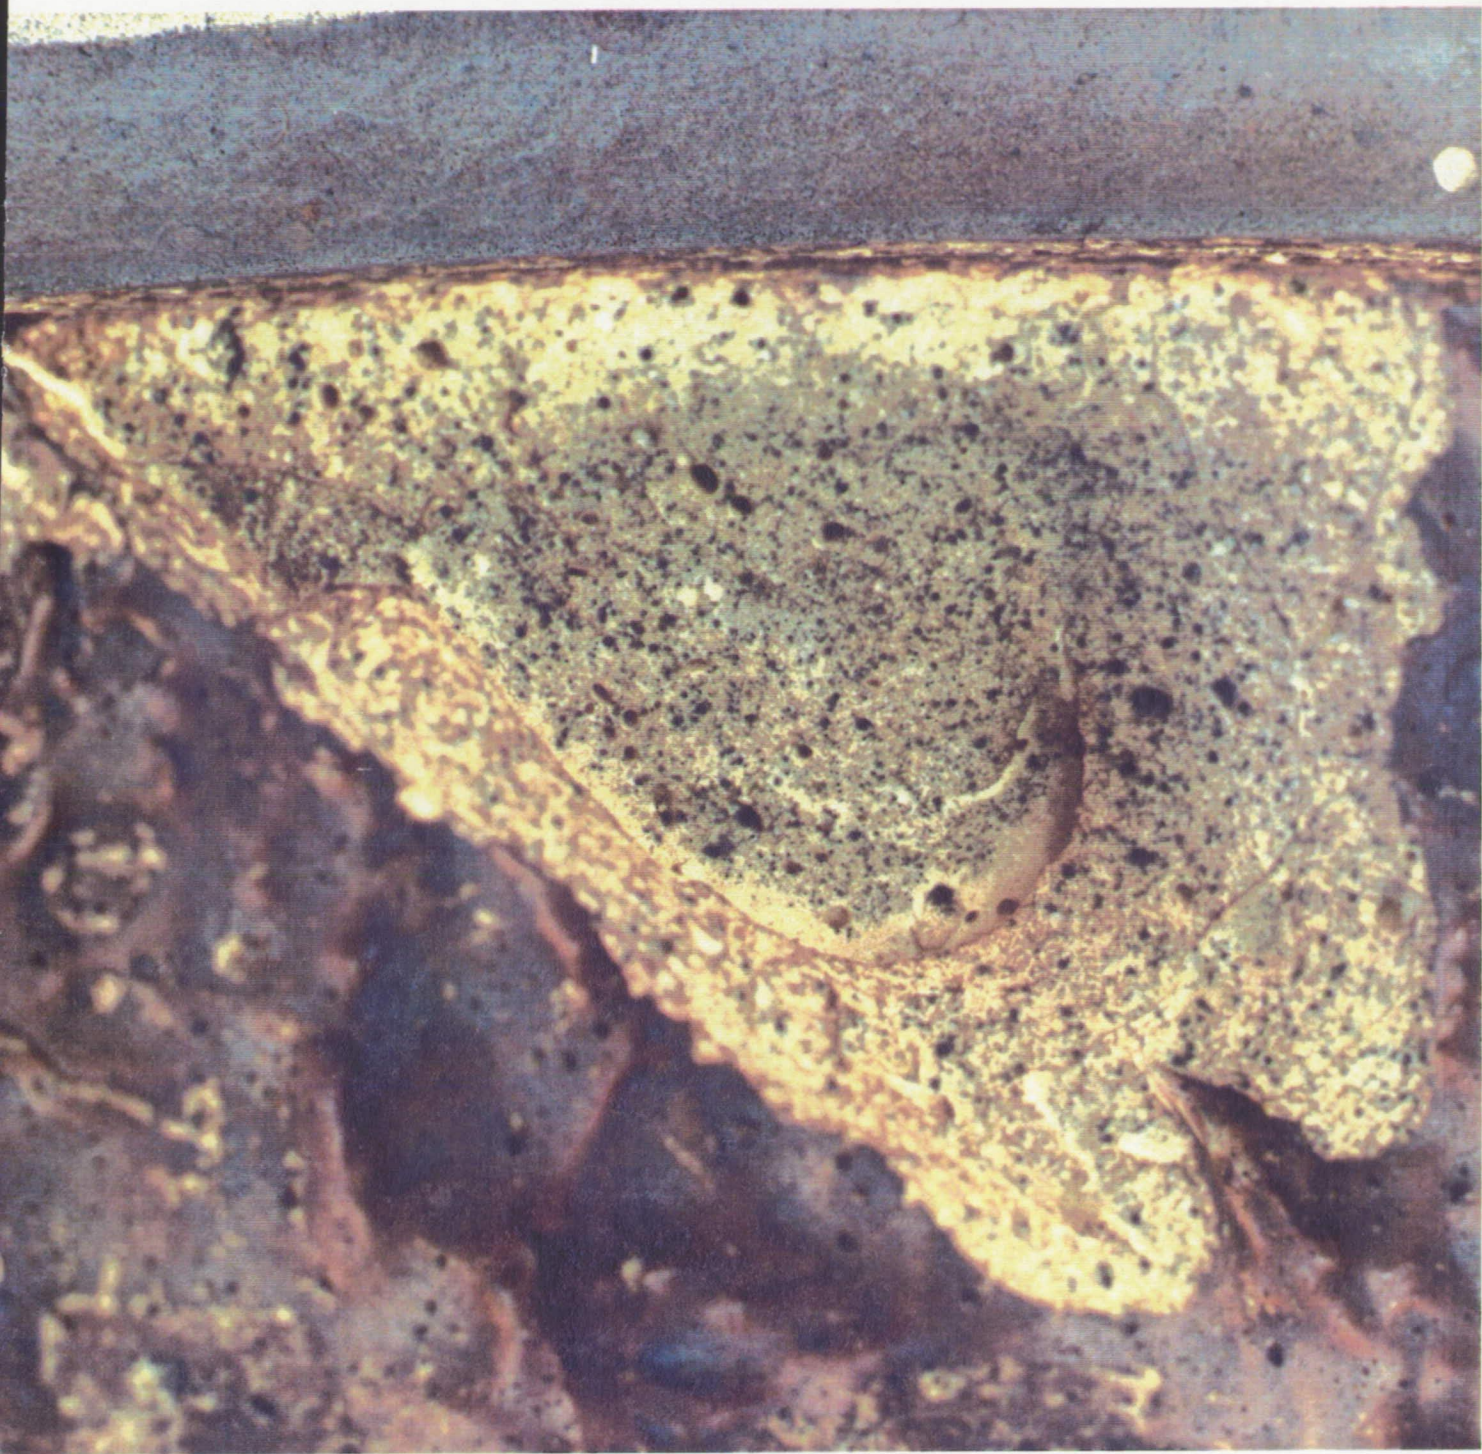
Close-in view of instafoam divot on the ETA ring forward side

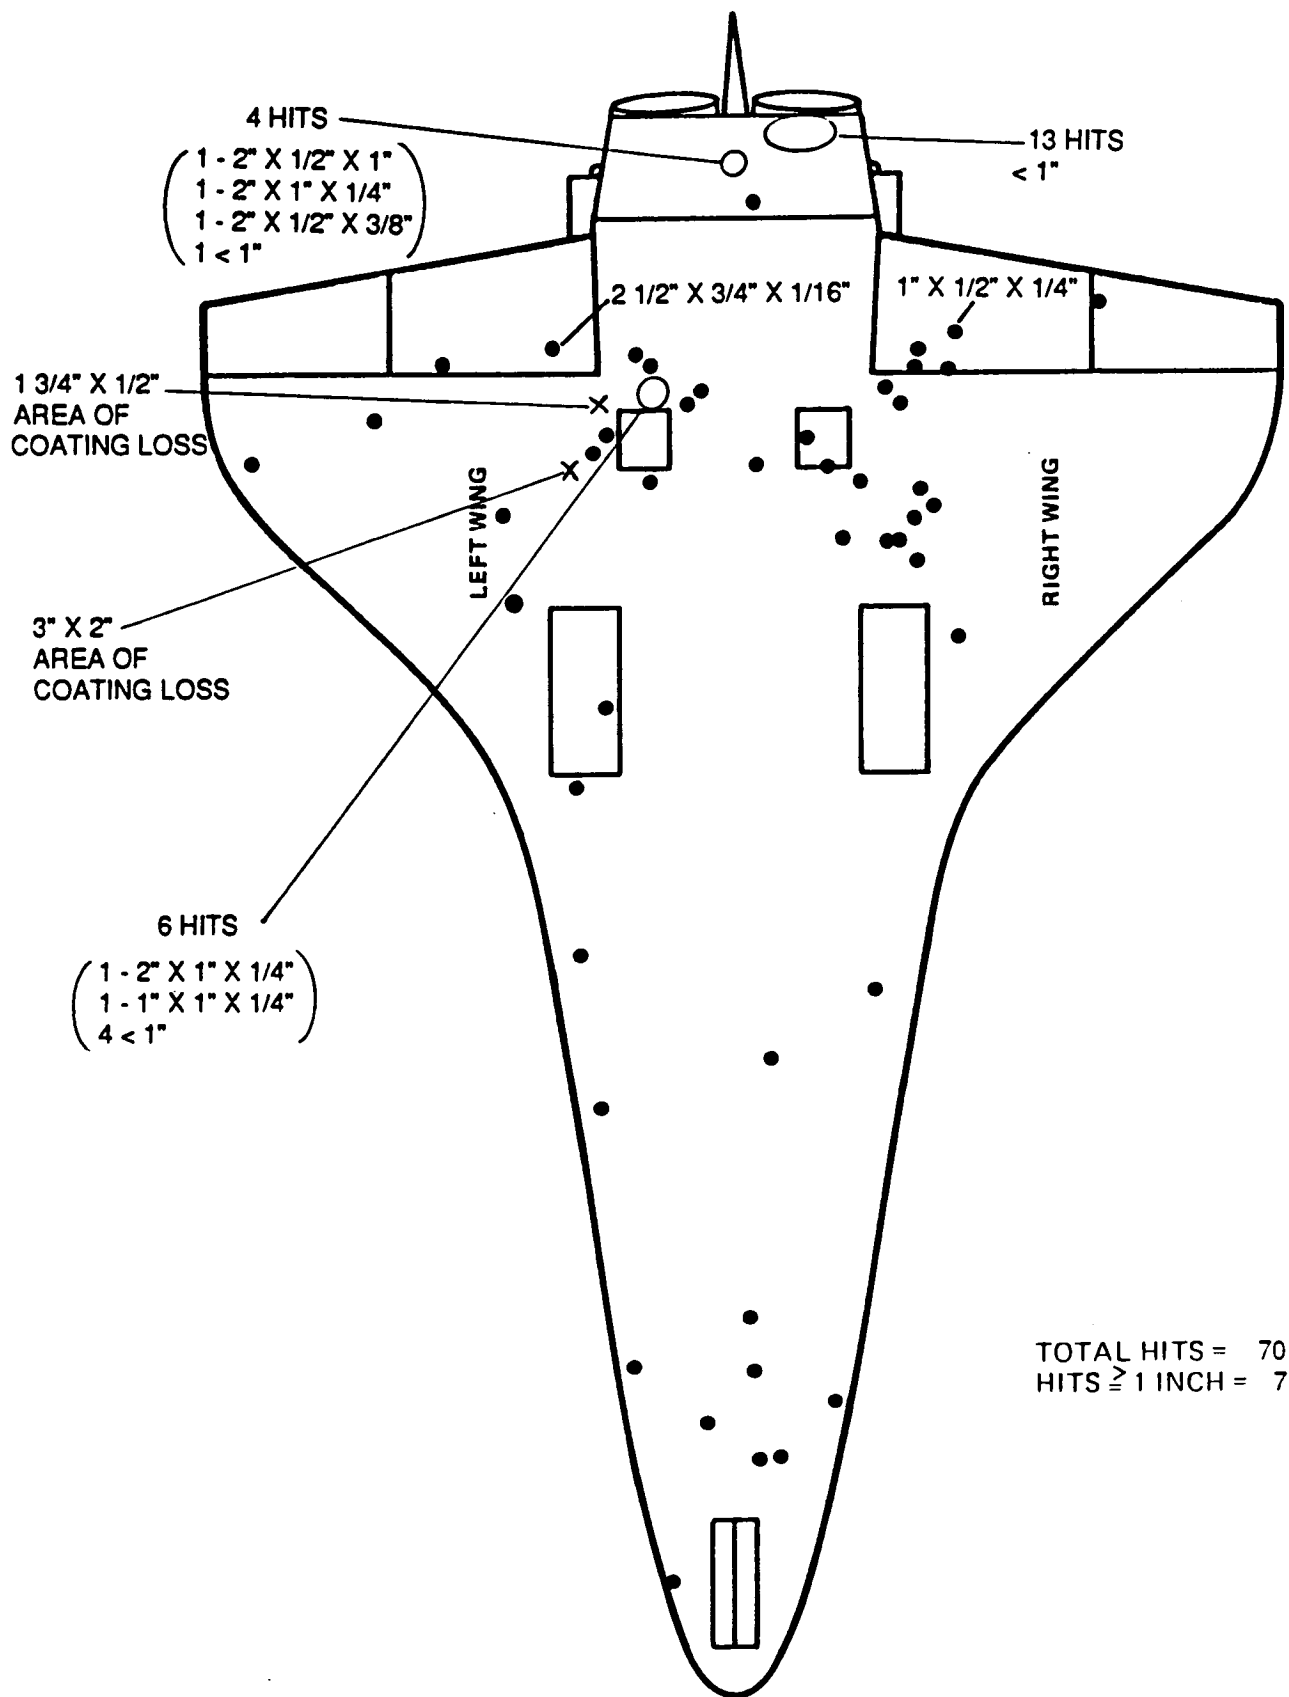
FIGURE 11. DEBRIS DAMAGE LOCATIONS

In summary, the total number of lower surface Orbiter TPS debris hits was less than average when compared to previous flights as shown in the comparison chart (Figure 17). The distribution of hits on the Orbiter does not point to a single source for ascent debris, but indicates a shedding of ice and TPS debris from random sources.

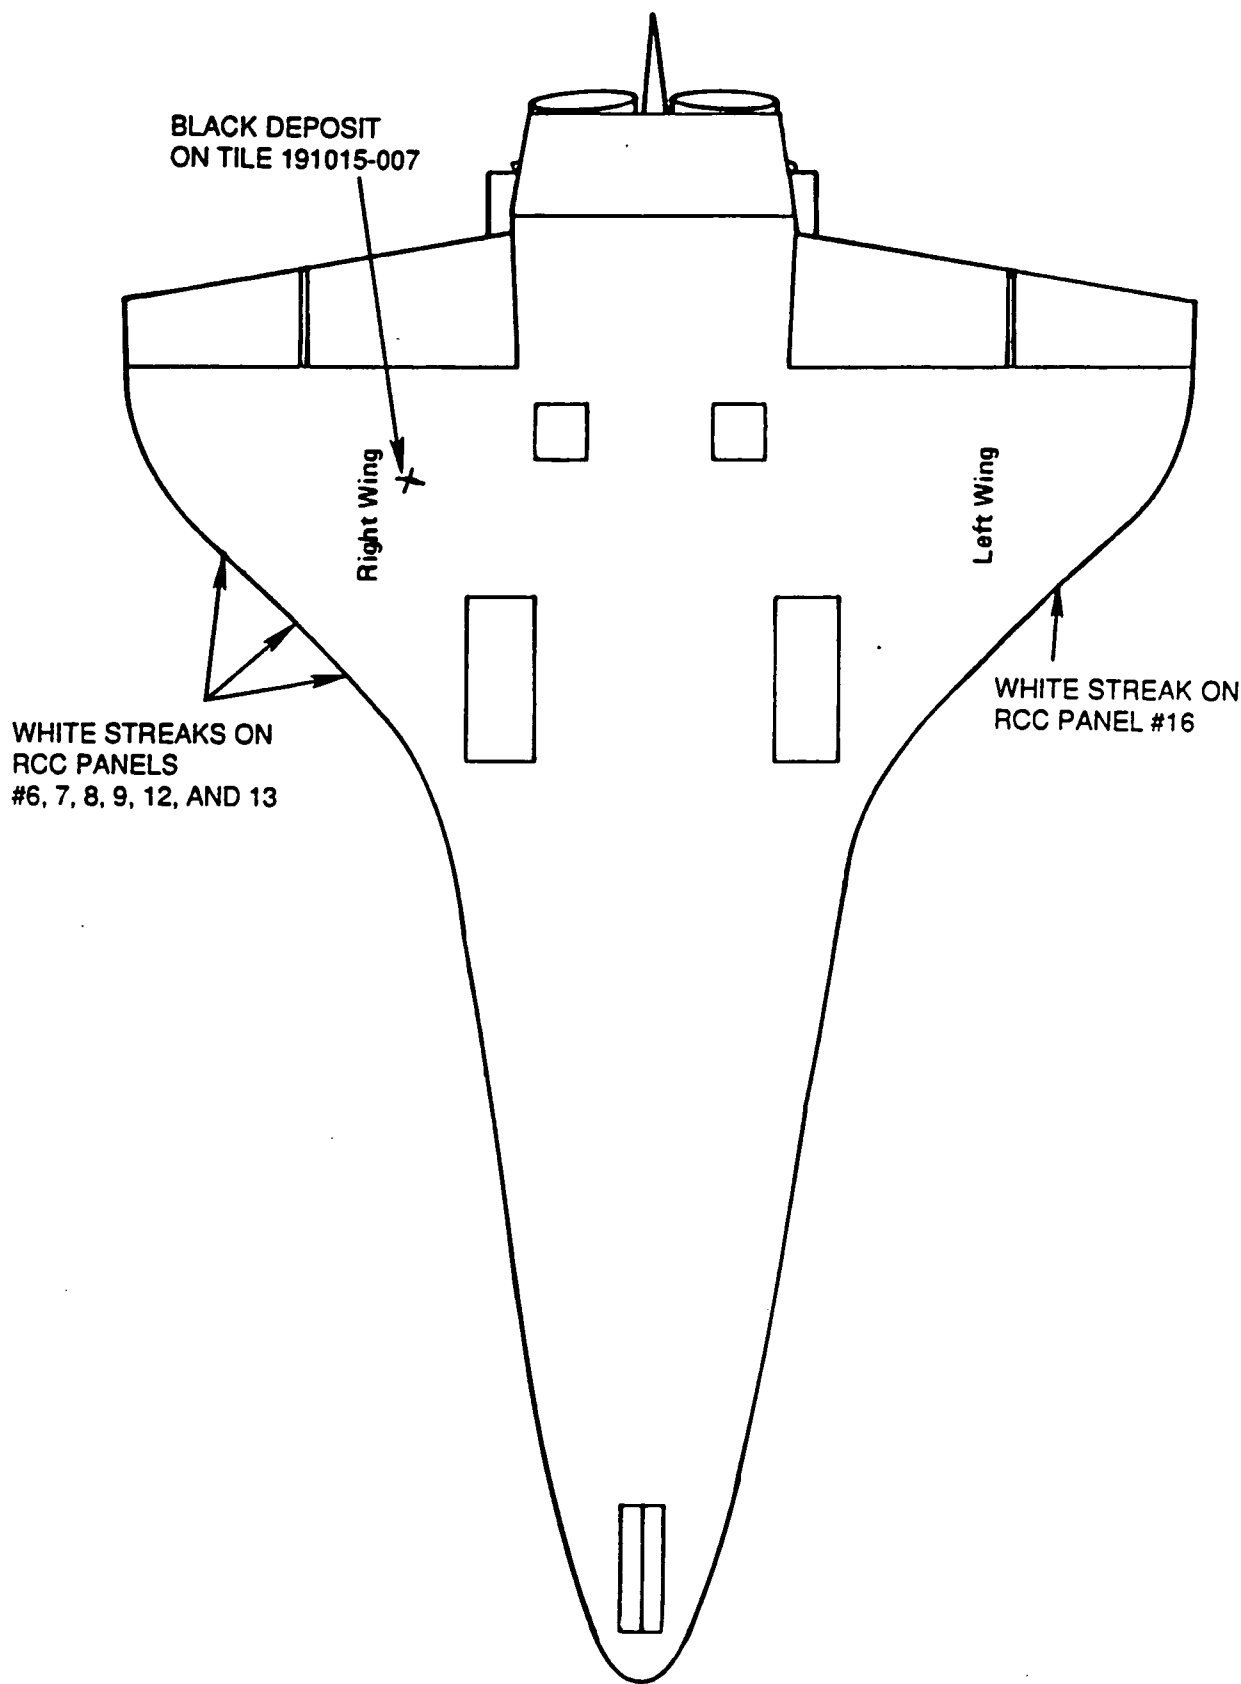
FIGURE 15. DEBRIS DAMAGE CHEMICAL SAMPLE LOCATIONS

After arrival in the OPF, samples were taken from the selected damage sites (Figure 15) for laboratory analysis. The results of all debris sample chemical analysis are presented in Section 10.0.

A total of 10 samples were obtained from Orbiter OV-104 during the STS-38 post landing debris assessment at Kennedy Space Center, Florida (Figure 15). The 10 submitted samples consisted of 7 wing leading edge RCC samples (6RH, 1LH), 1 tile residue sample, and reference samples: (1) foam "padding" used in wing leading edge RCC protective covers and (2) hypalon paint used in SRB processing. The samples were analyzed by the NASA KSC Microchemical Analysis Branch (MAB) for material composition and comparison to known STS materials. The specific elemental analysis is shown in the appended MAB report. Debris analysis involves the placing and correlating of particles with respect to composition, availability, and thermal (mission) effects. Debris samples and analyses are provided by Orbiter location in the following summaries.

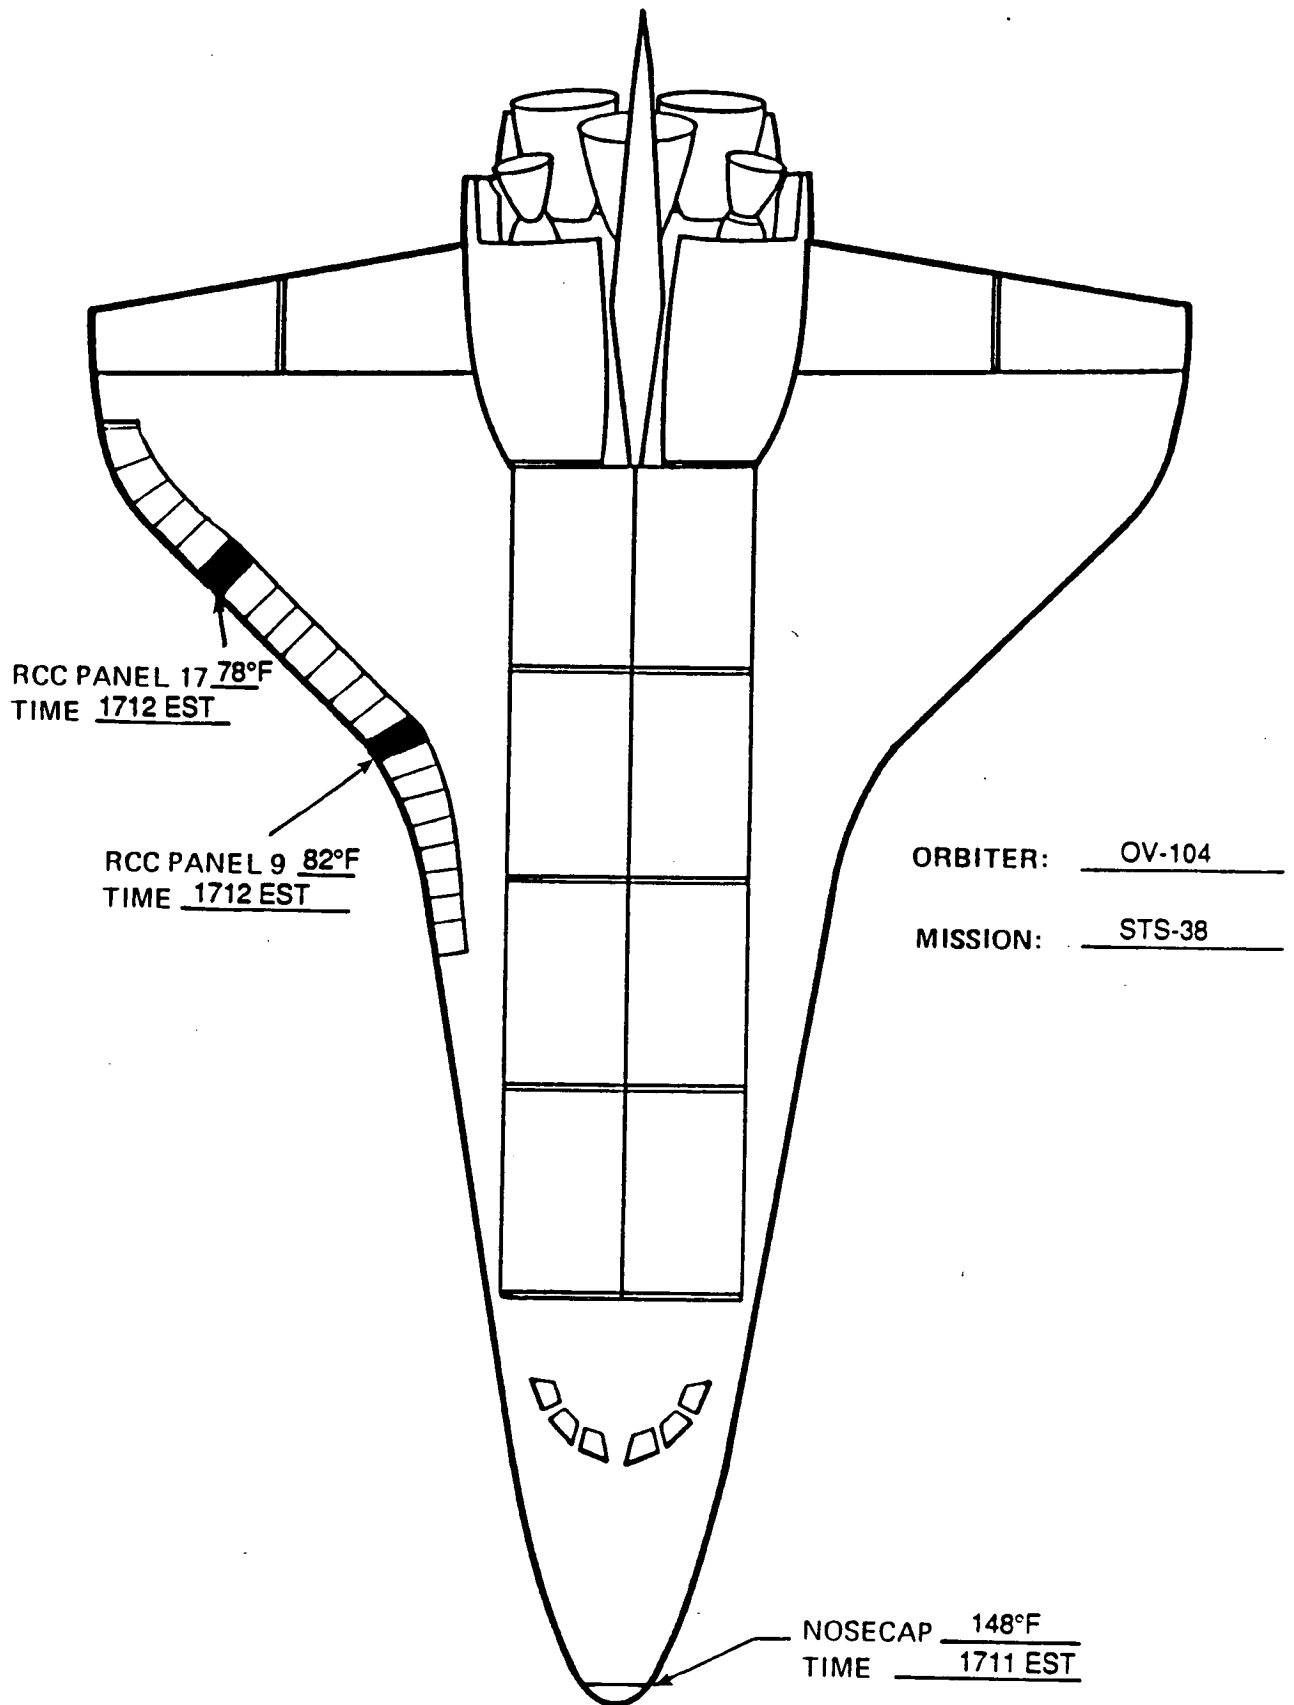
FIGURE 16. TEMPERATURE MEASUREMENTS

The KSC Shuttle Thermal Imager (STI) was used to record the surface temperatures of several areas (Figure 16). Twenty-eight minutes after landing, the nose cap RCC measured 148 degrees F. The RH wing RCC panel #9 and #17 measured 82 and 78 degrees F, respectively.

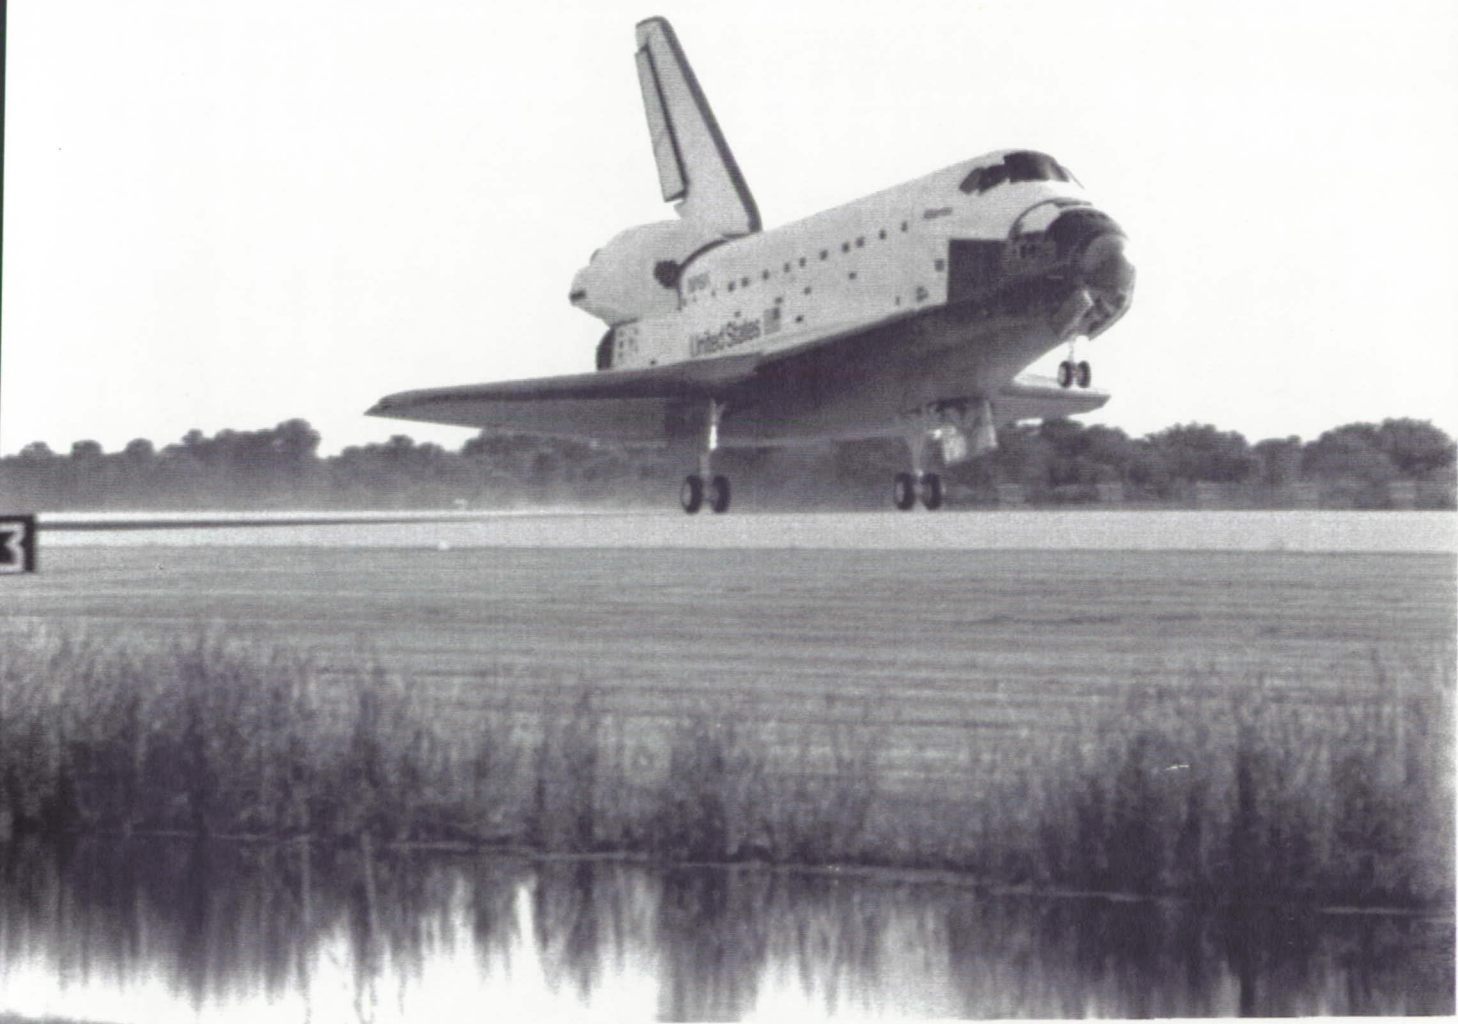
Two pieces of SSME closeout blanket, above the body flap near
SSME #2 and outboard of SSME #3, fell aft during final approach

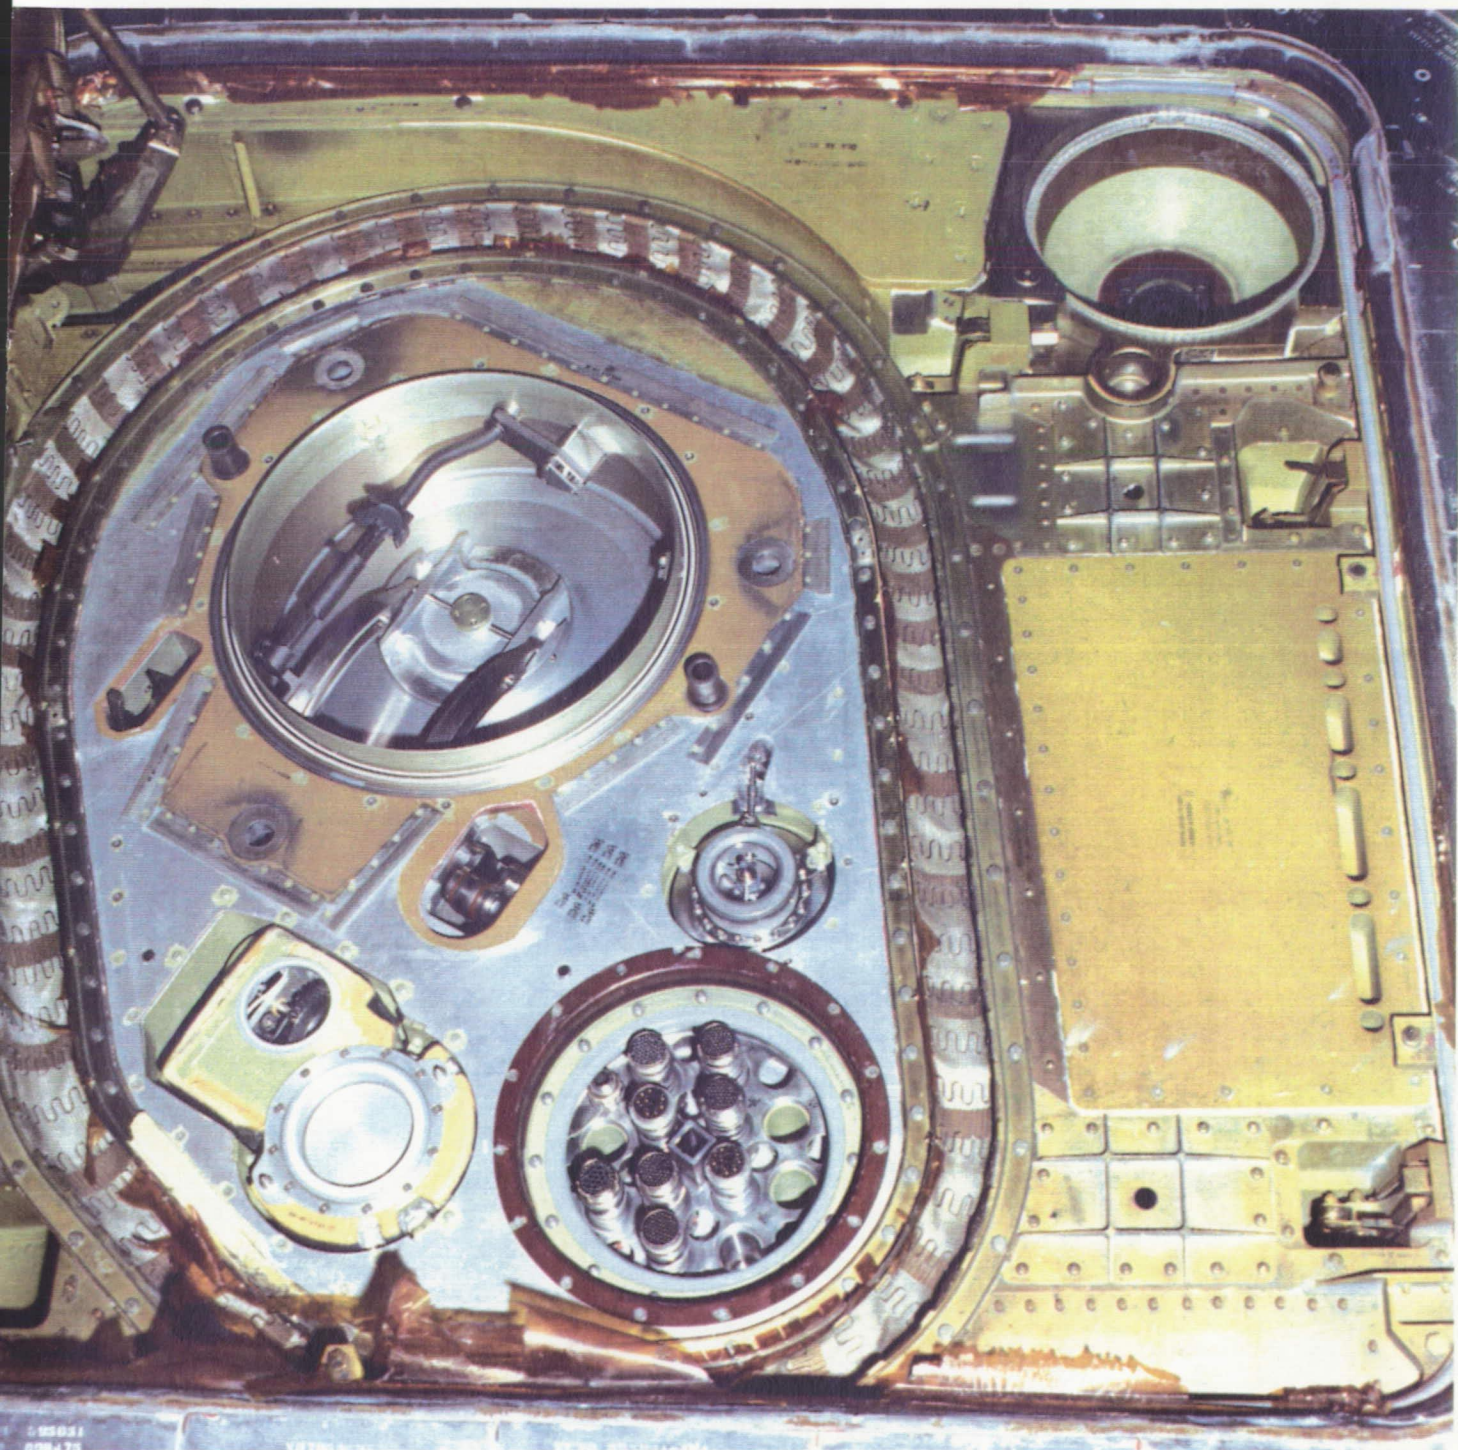
Post flight condition of the LH2 ET/ORB umbilical. The debris plunger in EO-2 was properly seated.
